HYDRAULIC MODEL STUDIES OF THE
BARTLETT DAM SPILLWAY
SALT RIVER PROJECT, ARIZONA

Report No. Hyd-576

October 2, 1967

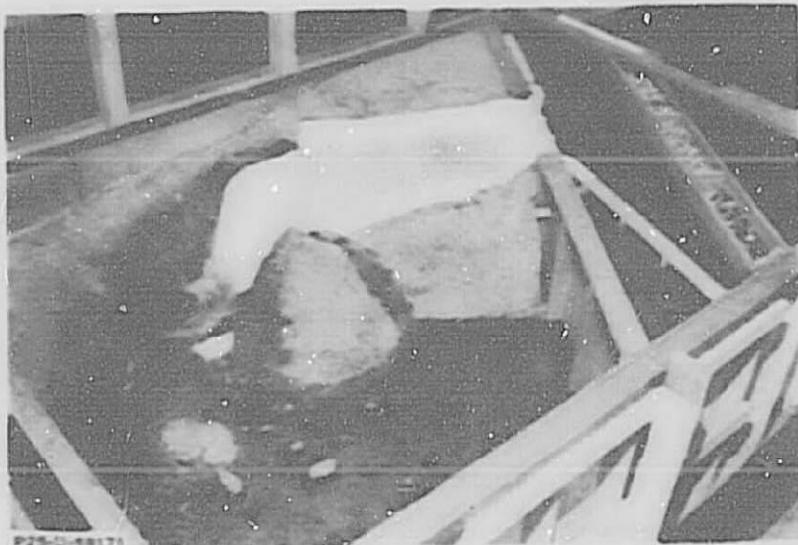
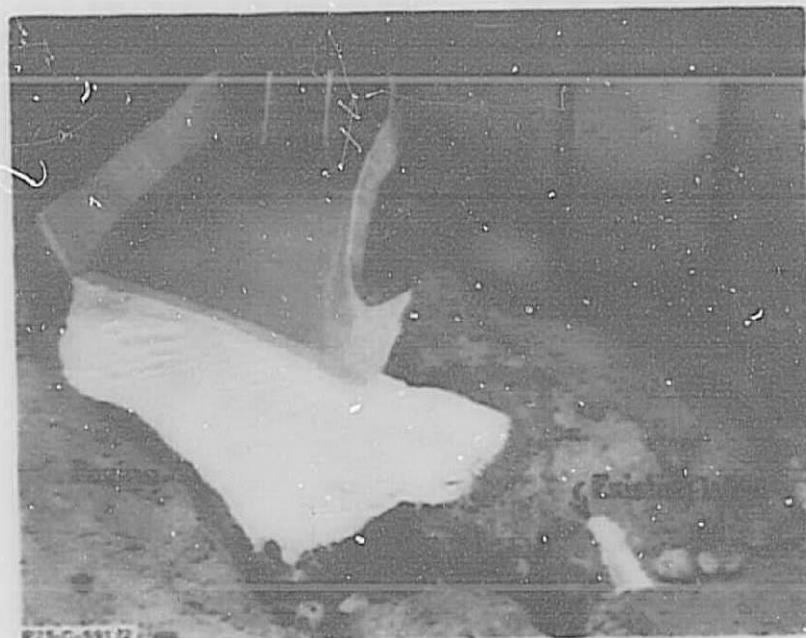
Figure 6
Report No. Hyd-576

The extent of concrete paving placed
in discharge channel following the
1965-66 flood is painted white.

BARTLETT DAM SPILLWAY
The 1:100 scale model

2. Repairs made after the 1965-66 floods appear to be well located for protection of the channel against further erosion, but the paving should be extended a little higher and farther downstream along the left bank (Figures 4, 9, and 11).

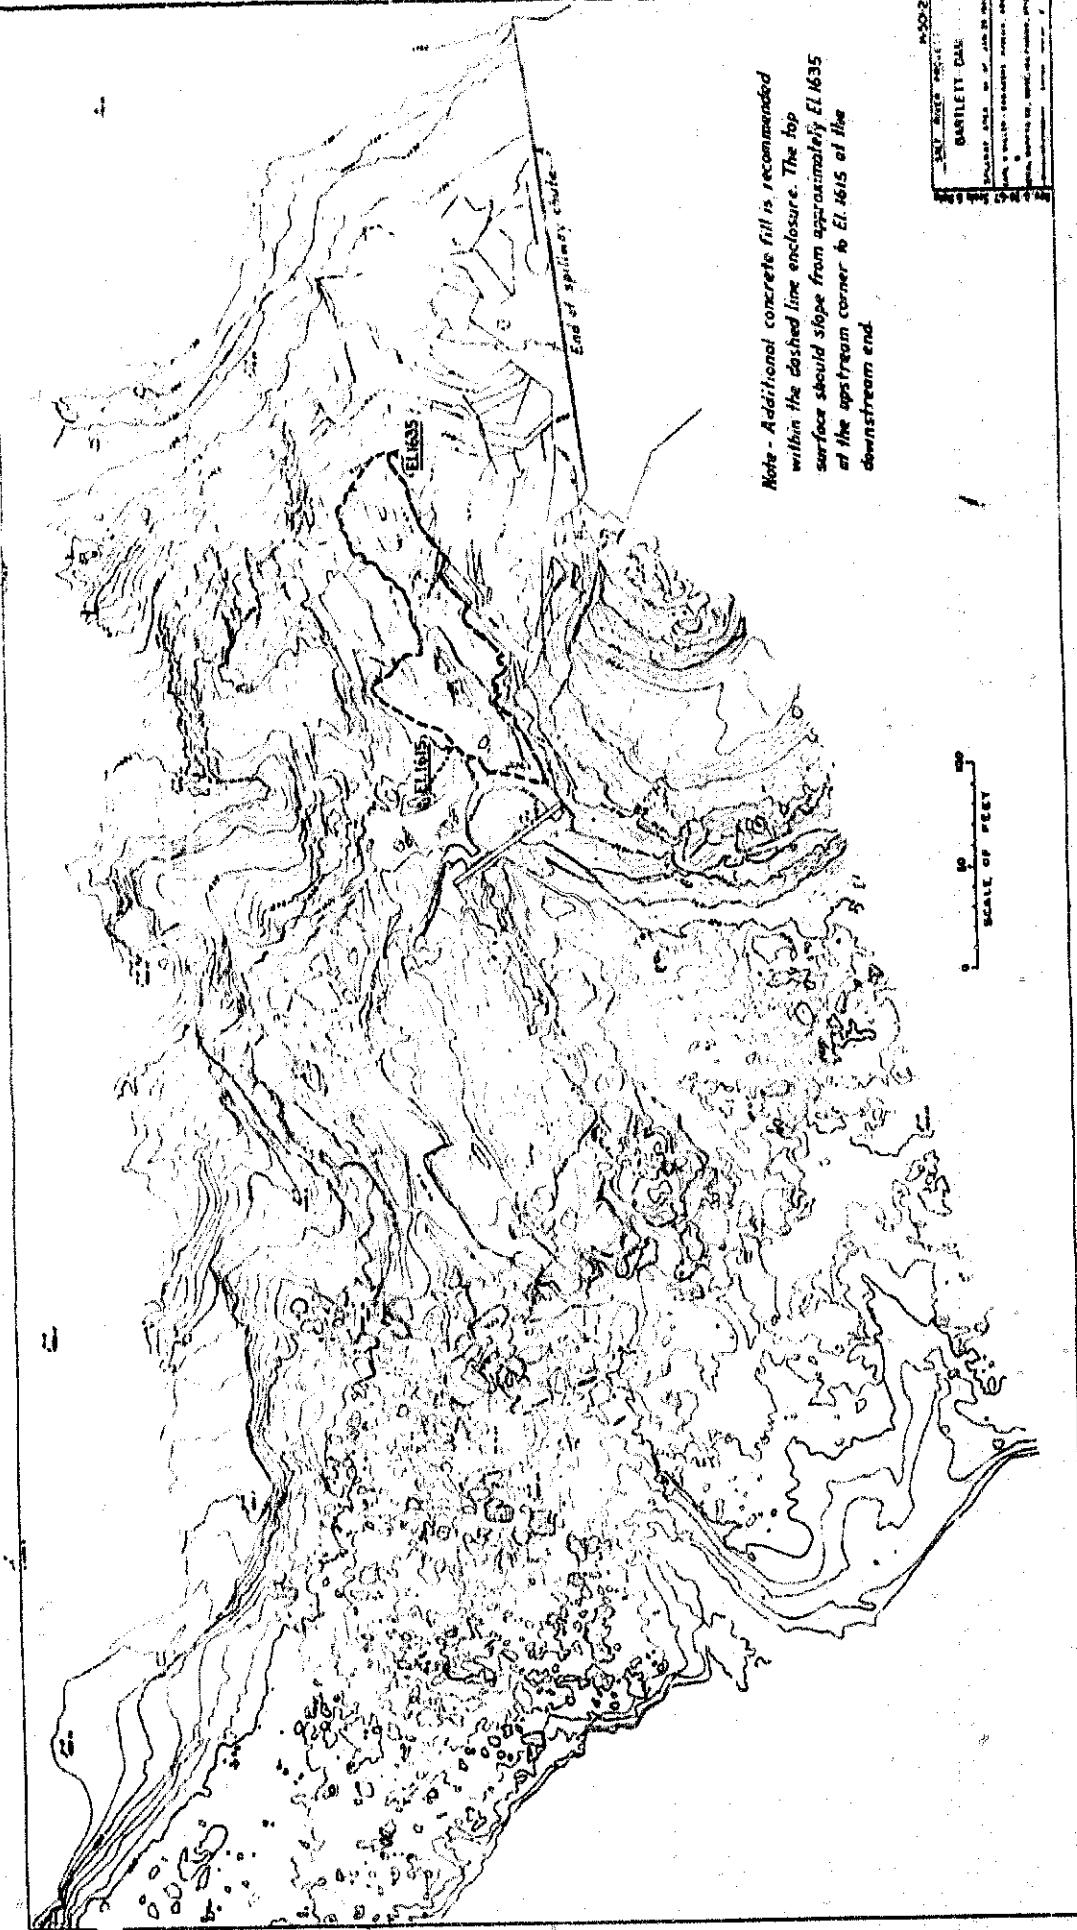
Figure 8
Report No. Hyd-576

The model was operated at discharges up to 50,000 cfs (1,415 cms) to determine flow conditions that might have caused the erosion. At discharges of 10,000, 20,000, and 50,000 cfs (283, 566, and 1,415 cms) flow from the spillway impinged on the areas that had been badly damaged in the prototype channel (Figure 8). The severest damage appeared to have occurred where the impact forces of the jet had apparently loosened and eroded the rock at the weathered joints. Initial tests made with the erodible channel indicated that the erosion began at the left downstream corner of the concrete-lined chute and progressed downstream as the discharge increased (Figure 9). This test confirmed the belief that the major portion of the erosion was due to flow impact rather than to rocks churning in the turbulent flow.

5. The spillway gates should be equally opened for best flow distribution at the flip bucket (Figure 8).
6. The two ridges partially blocking the downstream end of the channel should not be removed (Figure 13).
